## Building Inspection Report - Completion Stage

New Building Inspection - Completion Stage

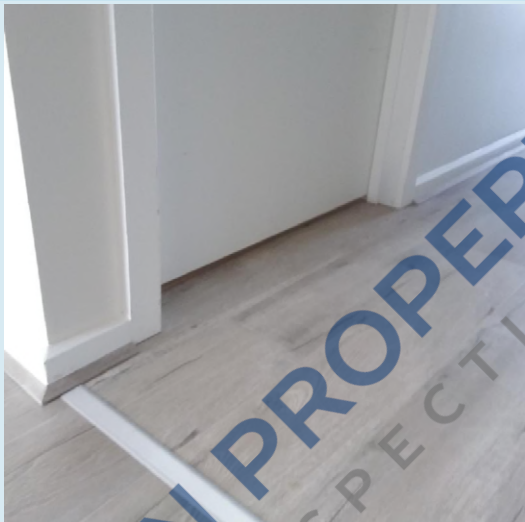
Hallways and General Living Spaces	
Repair Recommended	Doors
Comments	
A weather seal is to be installed on bottom edge of internal garage door to comply with energy efficiency requirements.

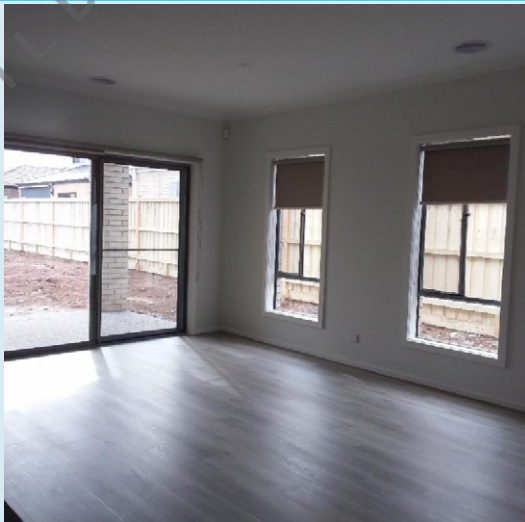
Hallways and General Living Spaces	
General Advice on Item	-
Comments	
Main living area appears to be visually fine at time of inspection.

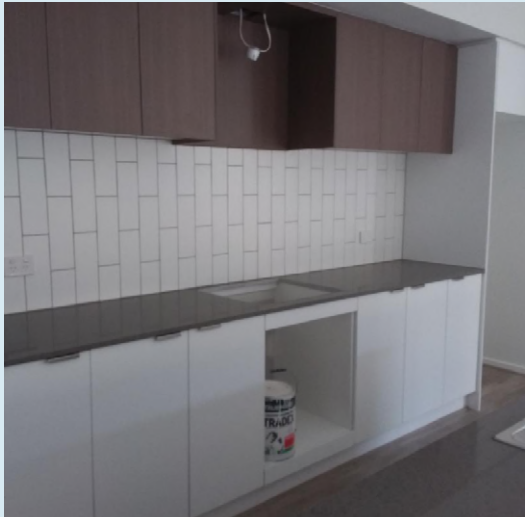
Kitchen	
General Advice on Item	Oven
Comments	
Kitchen appliances have not been installed at time of inspection however this is typically completed on day of handover.

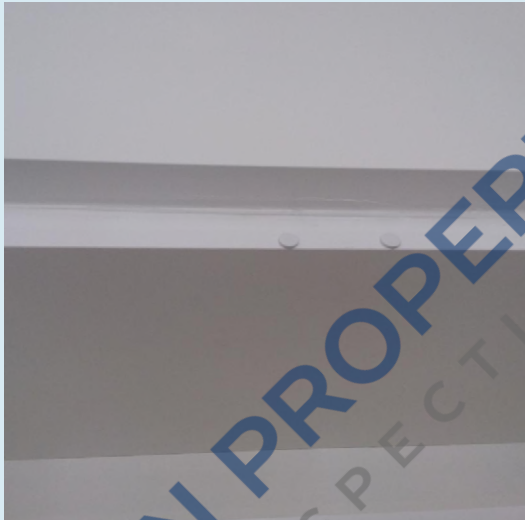
Kitchen	
Repair Recommended	Ceiling
Comments	
Bottom edge of bulkhead above overhead cabinets has been finished poorly in multiple locations and requires repair.

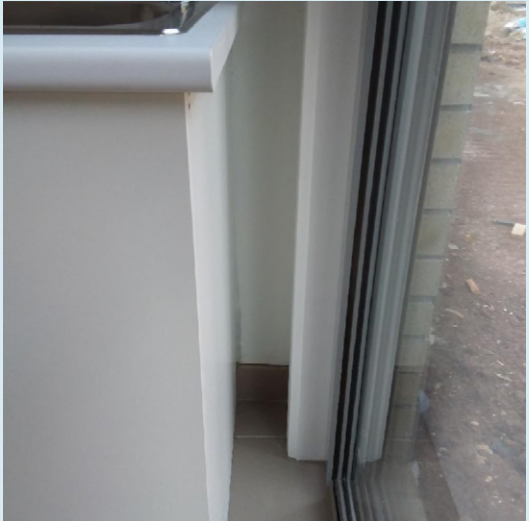
Laundry	
Repair Recommended	Walls
Comments	
Right side of laundry cabinet wall has not been fully painted and requires an additional coat to be applied.

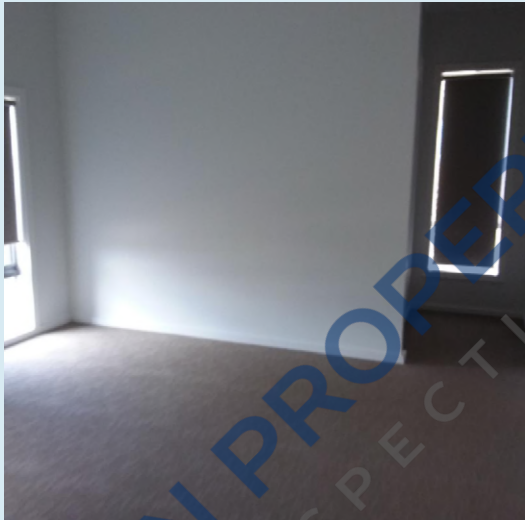
Bedrooms	
General Advice on Item	-
Comments	
Bedroom 1 appears to be visually fine at time of inspection.

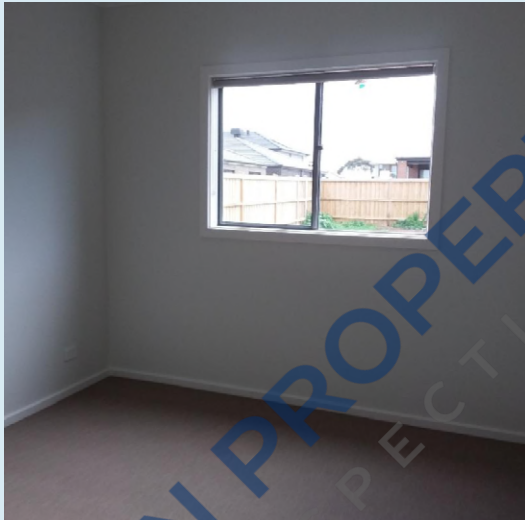
Bedrooms	
General Advice on Item	-
Comments	
Bedroom 3 appears to be visually fine at time of the inspection.

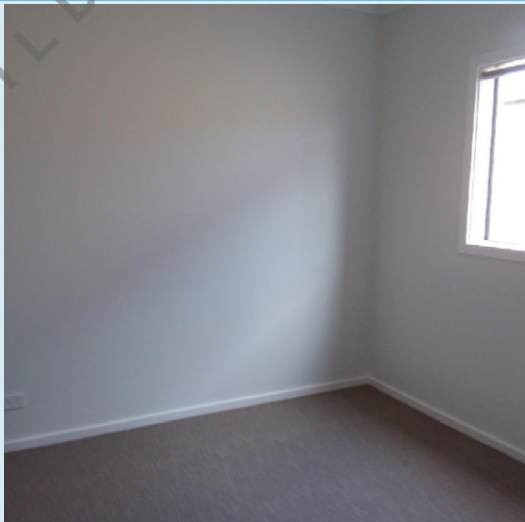
Bedrooms	
General Advice on Item	-
Comments	
Bedroom 4 appears to be visually fine at time of inspection.

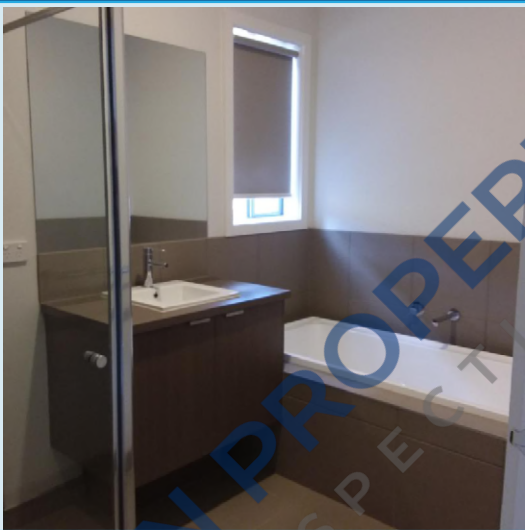
Bathroom appears to be visually fine at time of inspection.

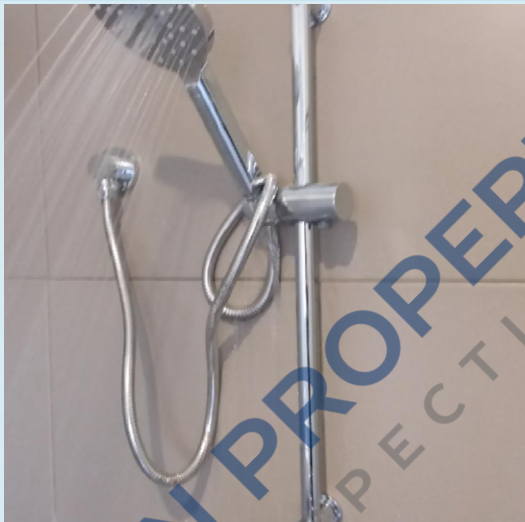
Ensuite	
Repair Recommended	Shower Rose
Comments	
Shower Rose is leaking between hose and shower head and requires repair.

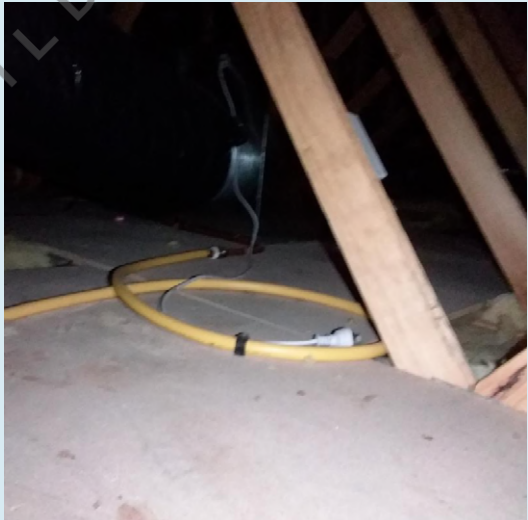
External	
General Advice on Item	Roof Space
Comments	
Unable to fully assess roof space due to ducting and trusses restricting access however did find that the power supply was not connected to heating unit indicating that this unit has not been commissioned at time of inspection.

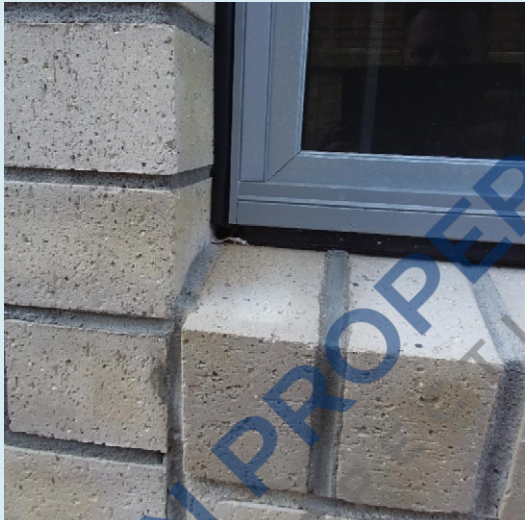
External	
Repair Recommended	Window Placement
Comments	
<p>The rubber seals on bottom edge of multiple windows requires extending so water does not penetrate into wall cavity.</p>

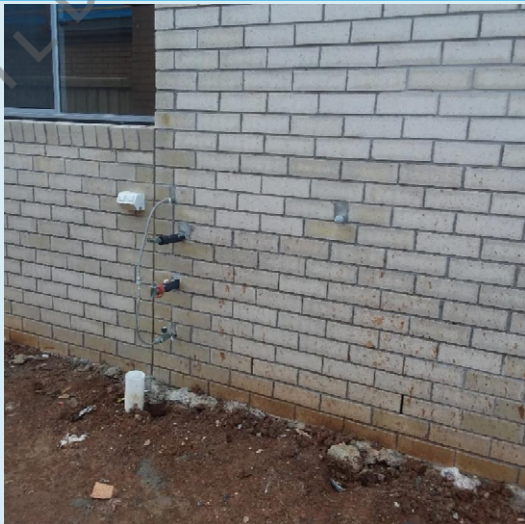
External	
Repair Recommended	
Comments	
<p>External appliances have not been installed at time of the inspection however this is typically completed on day of handover.</p>

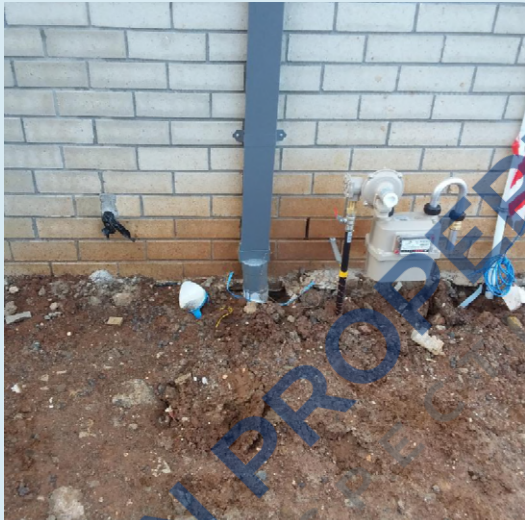
External	
General Advice on Item	-
Comments	
<p>Gas meter has been installed approximately 1000mm away from where gas point from house is penetrating dwelling, the gas line will need to be extended to connect to gas meter.</p>

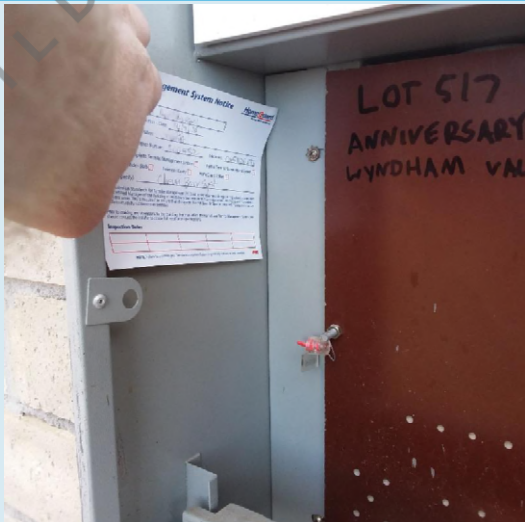
External	
General Advice on Item	-
Comments	
<p>A durable notice was found in meter box indicating a termite treatment has been conducted at this property however no details about the type of treatment were identified.</p>

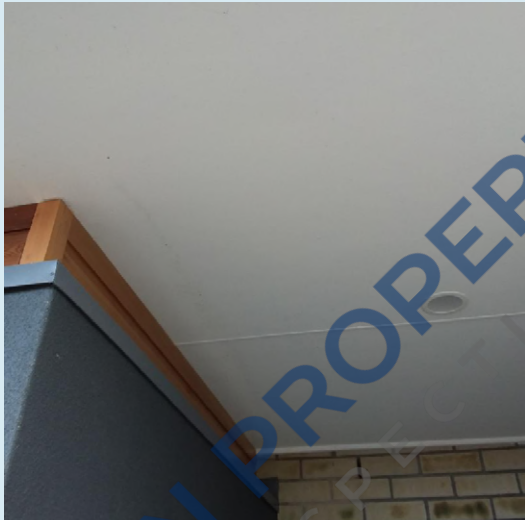
External	
Repair Recommended	Eaves
Comments	
Eaves sheeting at front of property has been painted poorly and requires an additional coat to be applied.

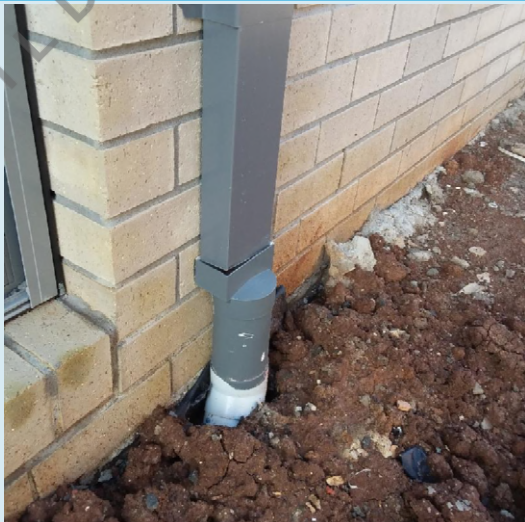
External	
Repair Recommended	Down Pipes
Comments	
Down-pipe near laundry is only just in contact with connector to drainage system and requires extending.

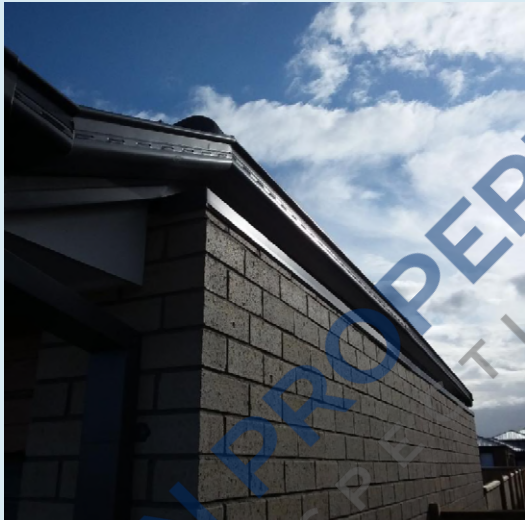
External	
Repair Recommended	Flashings
Comments	
<p>Flashing above garage boundary wall is sitting proud along front section and requires securing in correct position. There is also a gap between front section of this flashing and fascia which requires sealing.</p>
